# Manhole Inspection Summary

Manhole # S51EE\_005MH

Insp Date: **6/27/08 9:22 AM**

**Location** Address: **Kenwood**

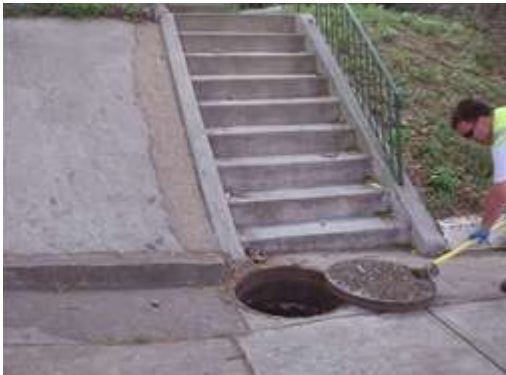
Location View

Cross Street: **Eager**

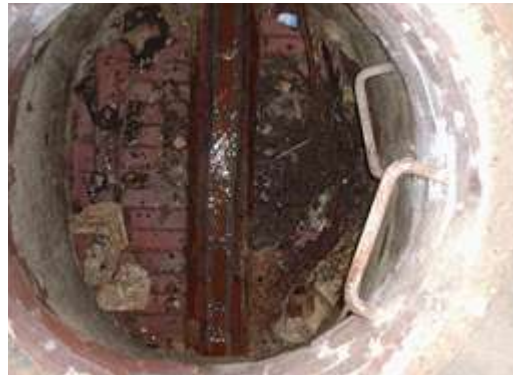
Top View

**Cover** Shape: **Circular** Diameter: **24** (in.) Length: (in.) Dist A/B Grade: **0** (in.)

Type: **Sanitary** Condition: **Sound** Cover Material: **Cast Iron**

**Frame** Offset: **2** (in.) Condition: ☒ Sound ☐ Cracked ☐ Leaks
